PROTECTION OF AIRCRAFT FLUID SYSTEMS

LTV Aerospace Corporation

TECHNICAL REPORT AFML-TR-68-125

May 1968

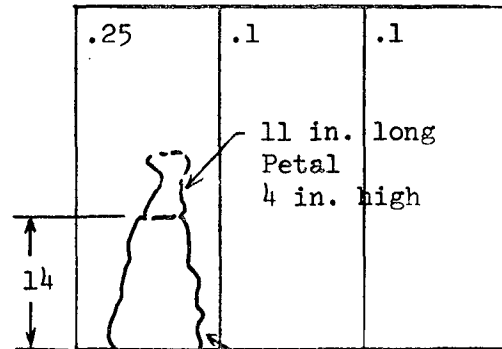
SKIN PANEL DAMAGE AND DEFLECTIONS

4 in. high Petal

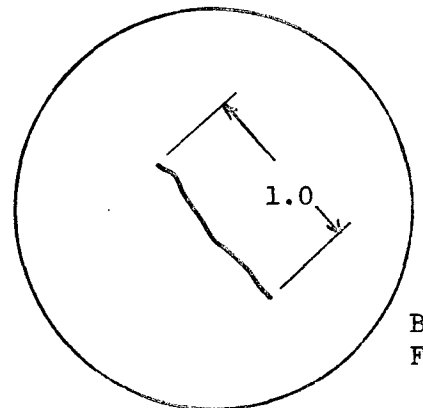
TANK DAMAGE

Back Side  
Frayed
